PM9A1 FW Change Notification

2022. Nov

Memory Business, Quality Assurance Division

- **Purpose : Samsung PM9A1 NVMe SSD F/W Change to 78 version**
- **Reason of change**
 - Fix side effect of 77version FW (* Samsung officially informed to hold 77ver)
- **Samsung internal schedule**
 - Samsung internal Qualification : Nov-16th-2022
 - Release schedule : : Nov-16th-2022

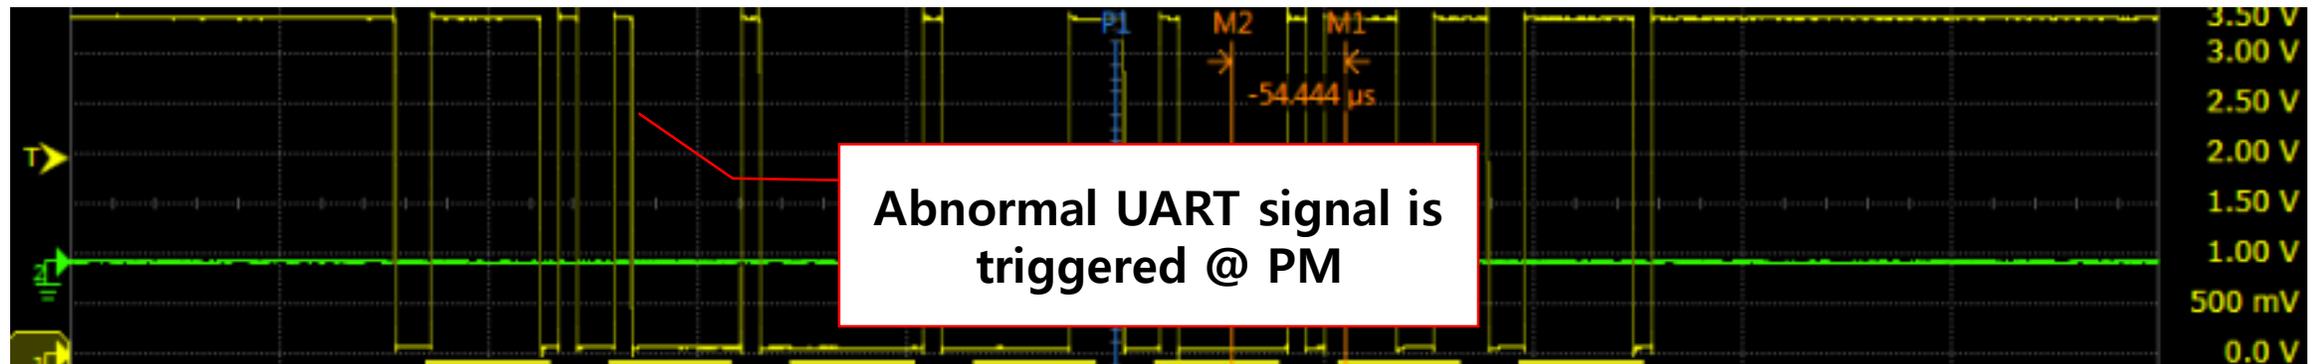
■ Issue: High power consumption observed at Modern Standby

- It is verified to be side effect of 77 FW item which is 'Improve FA debug feature: Support UART feature'
- While trying to enter power mode, FW mis-knew as if host UART command is triggered and stopped to enter power mode, and this increased power consumption

- Fix the wrong setting for FW mis-knew

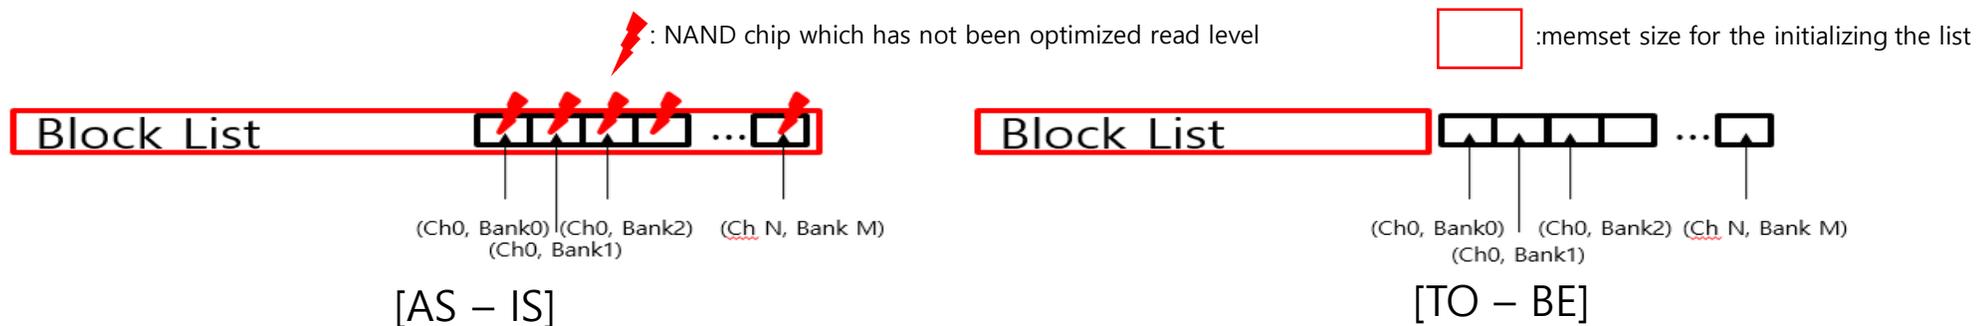
- Issue : Read Performance fluctuation @ CDM
- Root-cause : Read Level optimization step can be skipped from side-effect of fixing #4 @77FW
- Failure scenario
 - The re-arranging block list should be done during optimized read level setting parallel.
 - During Read level optimizing, in the process of initializing the list by using memset, due to a list size calculation error, the read level related FW meta information is corrupted.
 - So the NAND chip which has not been optimized read level is considered as the one which is already optimized read level.
 - Therefore, the read performance drop happened because when the block which has not been optimized read level is used and it causes protection code looping execution.
- Corrective Action
 - To fix error code - memset size

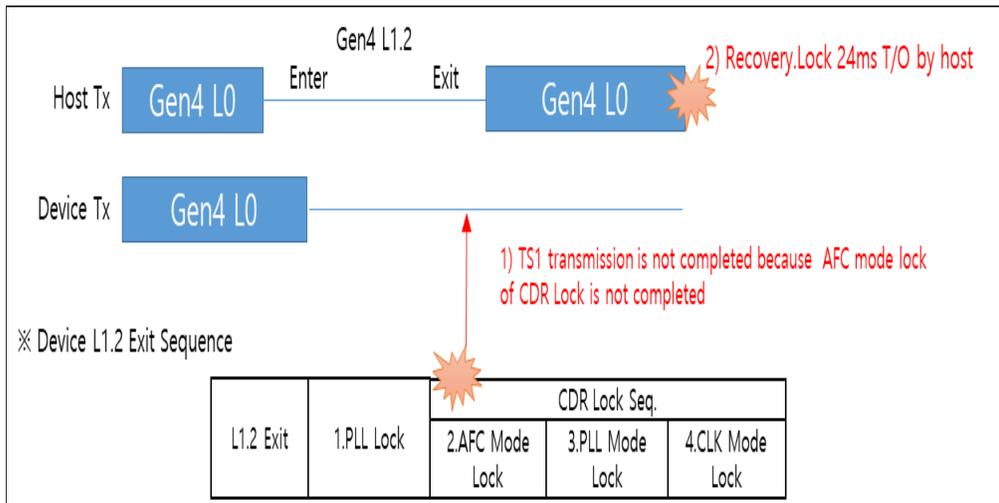
- Found Recovery.Lock 24ms Timeout when exit L1.2 during Modern standby testing

- Device couldn't send TS1 (training Sequence 1) to Host and finally Recovery.Lock 24ms Timeout occurred and Link down happened
- When exit L1.2, CDR (Clock and Data Recovery) Lock of CTRL is not properly completed [Fig 1]
- The slow completion of VCM(Reference voltage of VCO in AFC circuit) settling was observed with very low probability during the AFC Sequence
- VCO(Clock oscillation circuit) malfunctioned due to the slow completion of VCM settling at fail samples

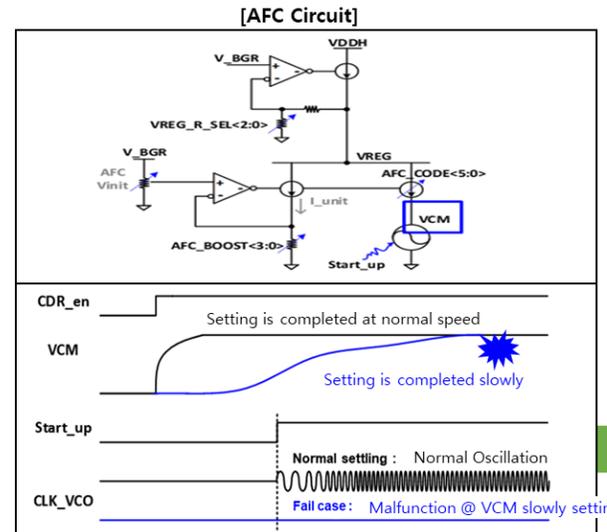
[Fig 2]

[Fail Mechanism]

- 1) SSD exit L1.2
- 2) VCM settling slowly during AFC @ Fail samples
- 3) VCO oscillator malfunctioned due to VCM settling
- 4) Can not meet target Frequency during AFC

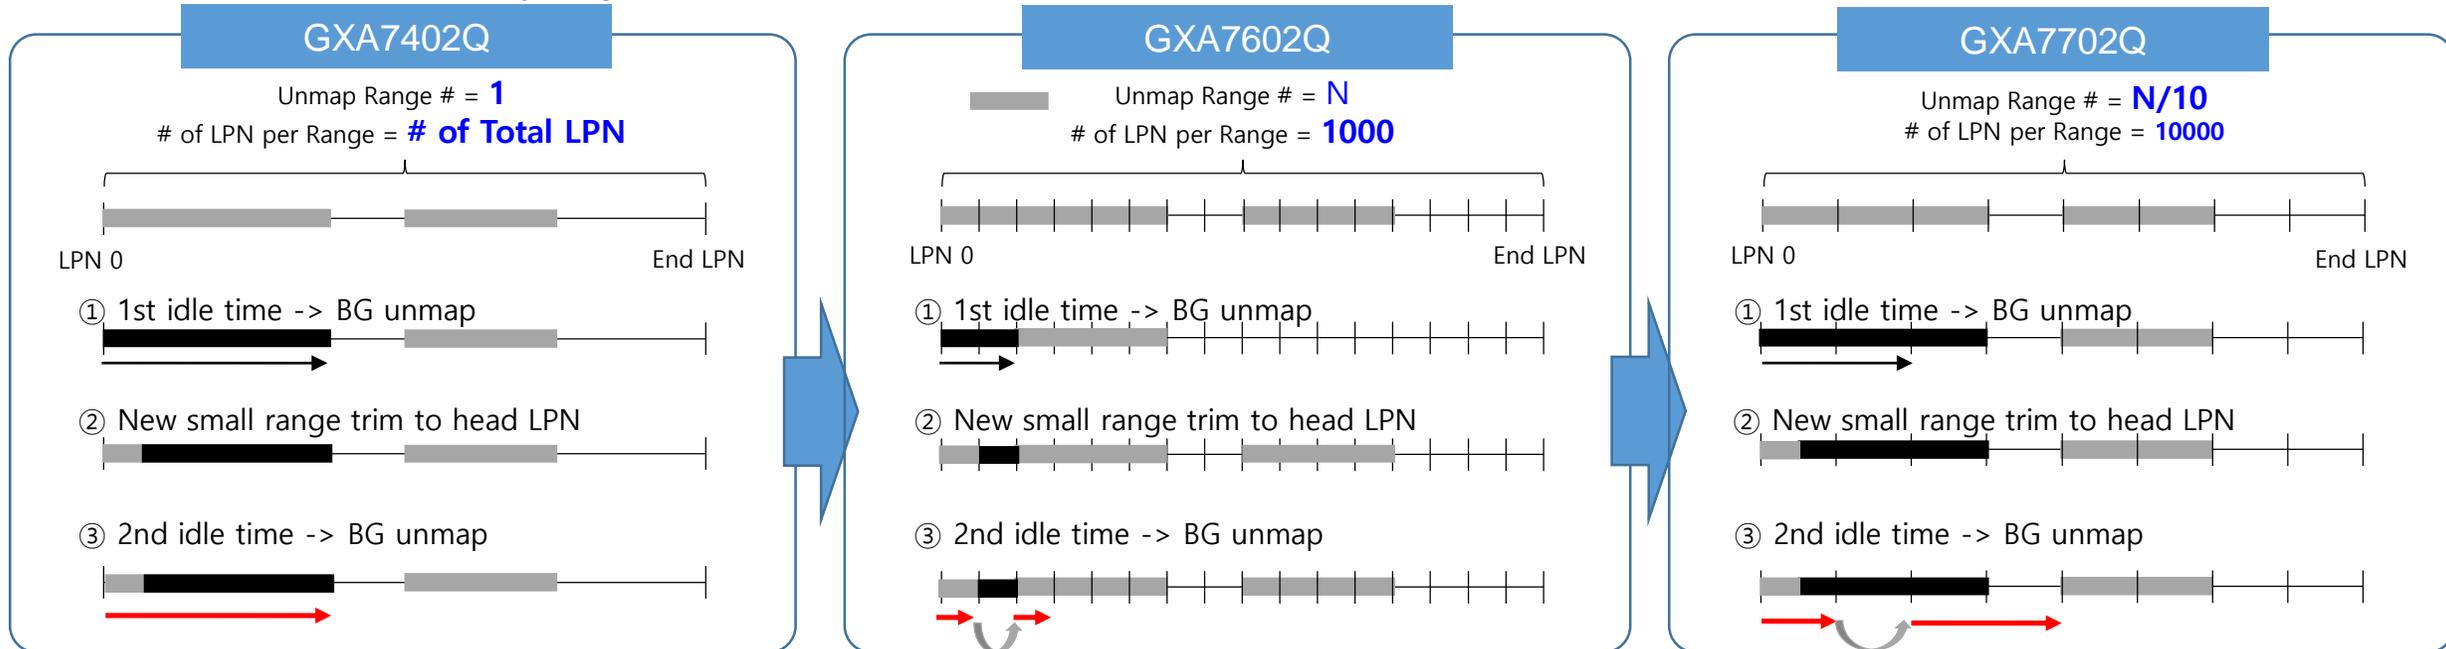
- SW encryption time takes so long

- It is related to side effect from previous Change item(Unmap process optimization)
- Splitting # of LPN per Unmap Range was essential to guarantee to enter PM, but # was excessively small @ GXA7602Q
- FW handling time for Unmap are lengthened → Free Blocks are generated more slowly
→ Ratio of unnecessary Migration & TLC write is increased

- # of LPN per Unmap Range needs change : Total # of LPN per Device (GXA7402Q) -> 1000 (GXA7602Q) -> 10000 (GXA7702Q)

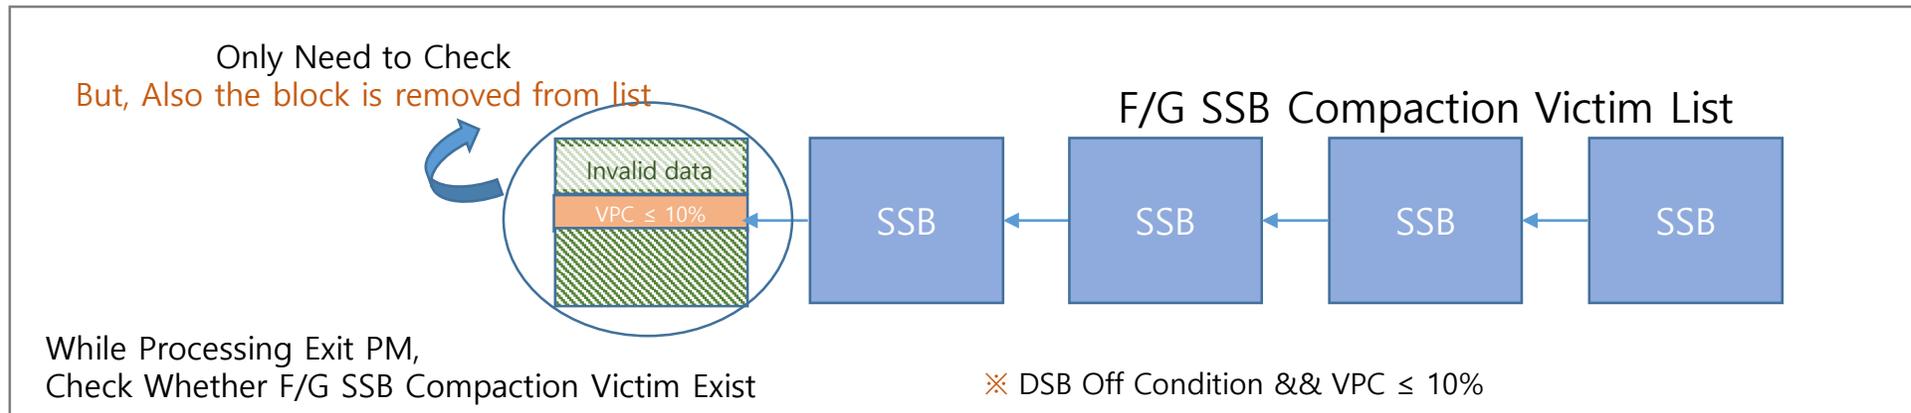
- Seq Write performance was dropped after long idle

- In DSB Off state, Foreground SSB Compaction(a kind of garbage collection) is executed to receive all write data from CDM to SSB as SLC area.
- FW checks the existence of the target block for F/G SSB Compaction in the process of checking whether there is a target SSB to perform F/G SSB Compaction after Exit PM – (Select list for Victim block)
- But FW removed the target block checked from the Compaction Victim List.
- SSB Free block cannot be created because the target block is not selected as Victim of F/G SSB Compaction,
- Finally, TLC write occurred because SSB doesn't have a room for write during CDM and Seq write performance showed TLC performance

- When exit PM(power management mode), FW only check whether the F/G SSB Compaction Victim exists and do not remove it from the list.

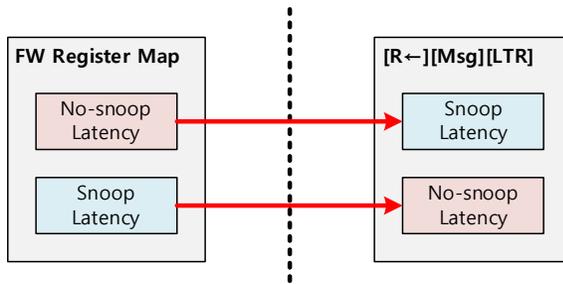
- LTR Latency value Register was reversed

- Register mapping related to Snoop/No-snoop latency of device FW Header was reversed.
